**Companie(s) :** Freyssinet Australia Pty Ltd  
**Owner :** GrainCorp Operations Limited

**Beginning of works :** 11/2010

**End of works :** 04/2011

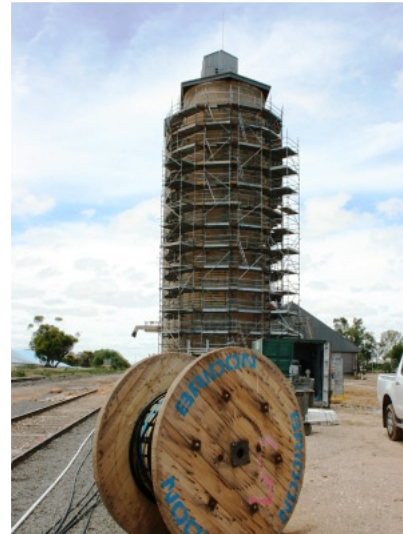
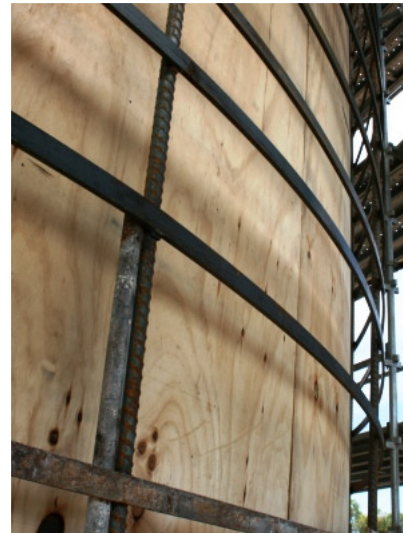
In December 2009, the reinforced concrete wall of a 1200t grain silo failed, dumping an estimate 500-600 tonnes of grain on to the ground and rail assets adjacent to the silo. The grain silo, part of a collection of four silos capable of holding some 2700-2800 tonnes, is a crucial link for GrainCorp in Victoria's remote Wimmera-Mallee region. Due to the extent of the damage to the structure and visual indications of further deterioration beyond the failure region of the structure, the scope of works for the project included strengthening of the silo structure as well as the remediation of the existing concrete wall.

Freyssinet's role on the project as head contractor included the removal and reinstatement of all steel reinforcing and concrete; design, supply and installation of external post-tensioning bands to reinforce the structure as well as the design, fabrication and installation of a new out loading chute, access ladder and platforms. Freyssinet completed both the external post-tensioning design as well as finite element analysis of the structure to determine the maximum allowable limits of the concrete break out – without propping - prior to the works commencing. Internal and external scaffolding was erected to provide access, followed by completion of the remediation works with the concrete reinstated using the wet-spray shotcrete method. Coring was completed through two 200mm thick reinforced concrete walls to enable continuity of the post-tensioning bands around the structure. In all, a total of thirty (30) external post-tensioning bands were installed, using custom PVC duct, 15.7mm high tensile, low relaxation strand and Freyssinet's X-Range (1X15) anchors. Corrosion protection for the external post-tensioning incorporated greased & sheathed strand, cementitious grout and calcium-based grease. Protection to the cast-iron anchorages was achieved using a UV-stabilised, resilient nylon coating. Despite the client delaying the start of the project due to prioritizing other works, the remediation and strengthening works were completed a week prior to Christmas in 2010, only a few weeks in to the harvest period ensuring that the repaired and strengthened structure could be utilized as required. In the coming months, the new out loading chute, access ladder and platforms will be fabricated and installed, completing the works successfully for GrainCorp.
