<b>Companie(s) :</b>	Vertigo Specialist High Access Services
<b>Owner :</b>	Tarong Energy
<b>Engineering consultant :</b>	Ian Godson & Associates
<hr/>	
<b>Subsidiary(ies) :</b>	Freyssinet Australia
<hr/>	
<b>Beginning of works :</b>	04/2008
<b>End of works :</b>	06/2008

**Description of the work :**

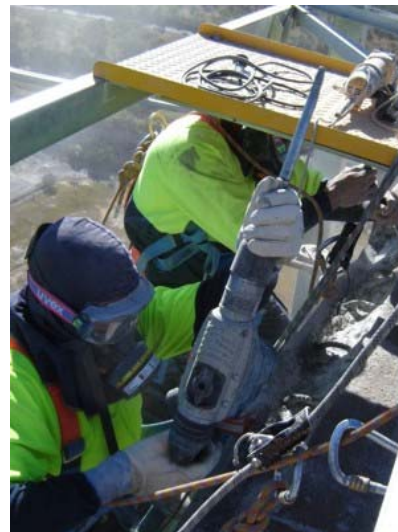
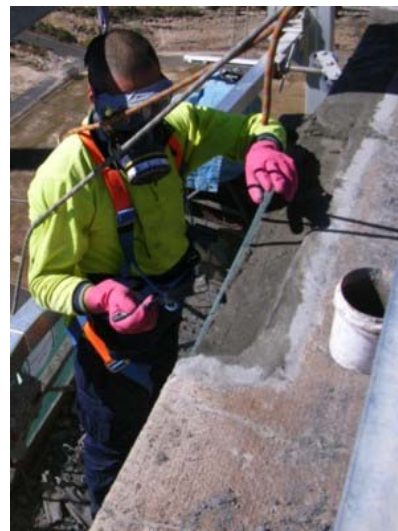
Freyssinet Australia was engaged in a "Construct" contract to undertake remedial concrete works and the application of protective coatings to the two cooling towers. The works were to be completed within the planned, staged shutdown of the power station between April and June 2008, under strict conditions that the plant had to be fully operational by 1 July 2008 to satisfy a major government supply contract. Freyssinet engaged Vertigo Specialist High Access Services as a major subcontractor to supply, install and operate the access systems required to complete the works. This consisted of four sets of custom designed and built adjustable steel frames, complete with powered long travel wheels, which were to sit atop the 600mm wide rim of the cooling towers. Each of the frames were installed/removed via helicopter and were fitted with two swing stages; one internal - to provide safe access to the top of the cooling tower, independent of the weather and one external - to provide access to the external work areas. The completed works consisted of 582m of crack repair, 12.25m<sup>2</sup> of concrete repair and the application of protective coatings to the upper 10m (external), top rim (600mm) and upper 500mm (internal) of each of the towers, which amounted to a total area of 4500m<sup>2</sup>.
